Drying and Coating Concrete at the National Aquarium

Case Study: Drying and Coating Concrete at the National Aquarium

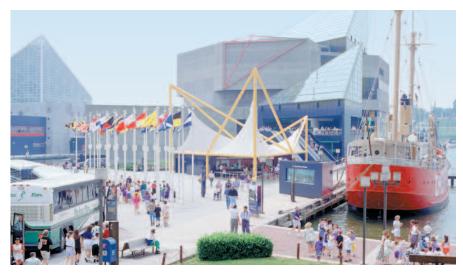
At the National Aquarium in Baltimore, Polygon helped the contractor dry out wet concrete quickly, improving adhesion and keeping the project on schedule and on budget.

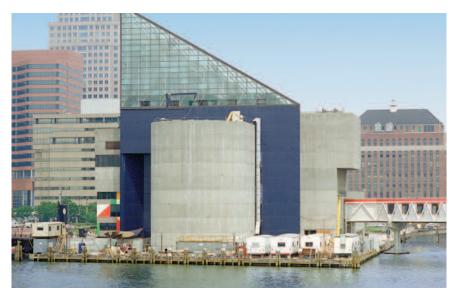
Yellow duct delivers the required dry air to lower levels.

Handling a difficult site problem – normally, large dehumidifiers would have been used to dry the 130,000 cu. ft. tank at Baltimore's National Aquarium, but limited on-site space required a more flexible solution. Polygon's versatile fleet provided combinations of lighter and smaller dehumidifiers which could be positioned in available locations.

On-site logistics were a particular challenge because the aquarium is located on a short pier, with essentially no space around the building for climate control equipment or for generators. Polygon provided a solution with equipment small enough to use on-site power and light enough to be placed on the roof. Dry air was brought through flexible hose down into the tanks. Duct runs of more than 100 ft. were common as the requirement for dry air moved throughout the building.
